SUBSEA

PROTECTION AND PERFORMANCE

Magazine

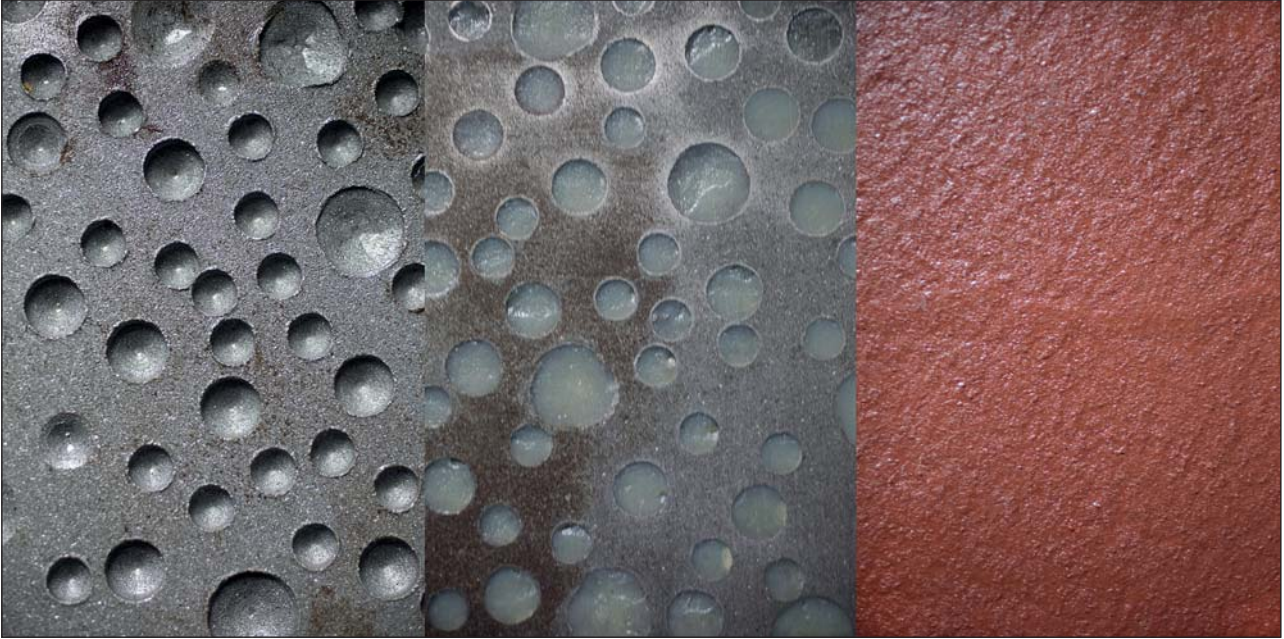
Test plate showing the benefit of an Ecofix and Ecoshield combination.

Subsea Industries has launched a new product for filling and building up a corroded and pitted steel surface to its original form prior to recoating with Ecoshield. Ecofix is as tough as the steel itself, machinable, and can be used to repair most pitting or corrosion damage on rudders, stabilizer fins, thrusters and other underwater gear.

Ecofix is used in combination with Ecoshield, the ultimate rudder protection coating. When a rudder or other piece of underwater ship gear has not been properly protected, the surface will become corroded. Cavitation damage can cause severe pitting. The steel needs to be restored to its original shape with a smooth surface prior to recoating.

This is where Ecofix comes in. It is a superior, tested and proven filler. Because it uses the same basic resin as Ecoshield, the coating can be applied just one hour after the filler. The bonding and hardness are extraordinary. This is the effective alternative to metal facing or very expensive alternative fillers. And because it is part of the Eco-speed/Ecoshield family, it is fully compatible with the coating. ■

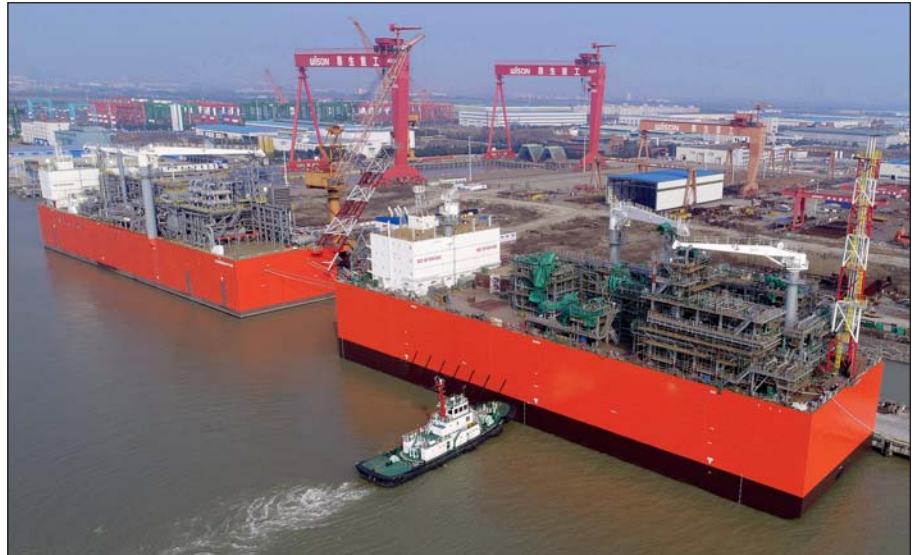
Floating Storage and Regastification Unit (FSRU) during its undocking.

Earlier this year application of Ecolock was finalized on a newbuild Floating Storage and Regastification Unit (FSRU) in China. This was the second project carried out for EXMAR, after the application on the *Caribbean FLNG* in 2013.

Like the first project, the FSRU was built in blocks. These blocks are coated individually before assembly, leaving only the weld seams and the areas inaccessible due to the support blocks to be painted after the barge is assembled. Coating over weld seams after the blocks have been assembled is very easy. The Ecolock system then consists of a single, homogenous covering of the steel. It leaves a smooth finished surface and the erection joint paint blends in perfectly with the coating of the rest of the hull.

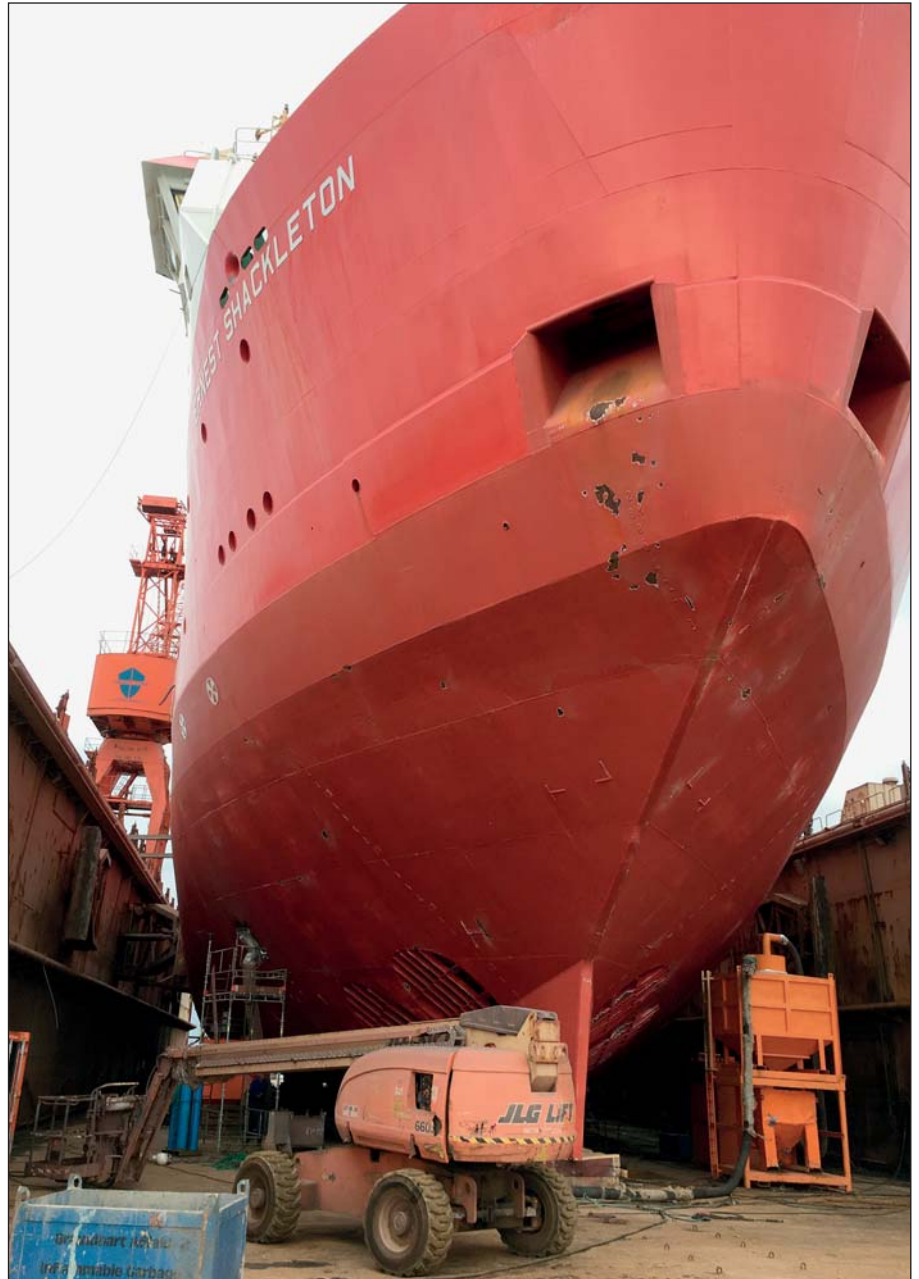
Only a small patch had to be touched-up during the recent docking, despite the Ernest Shackleton encountering heavy Antarctic ice.

In eight seasons operating RRS *Ernest Shackleton* with Ecospeed coating, BAS had to touch up Ecospeed only in areas of mechanical damage and carry out minor repairs around the bow, the most susceptible area to ice impact. Following the performance on *Ernest Shackleton*, the hard coating was applied in 2015 to the hull of sister ship, RRS *James Clark Ross*. Results were again exemplary. *James Clark Ross* is scheduled to drydock next month.

BAS Superintendent Andrew Webb, said: “*Shackleton*’s hull condition is the best I have seen after typical ice year operations.” After sailing for six years BAS had to account for touch-up coats to areas impacted by the ice during the many seasons in the Polar region. This year they

needed to repair even less surface area than expected, despite the vessel encountering heavy Antarctic ice.

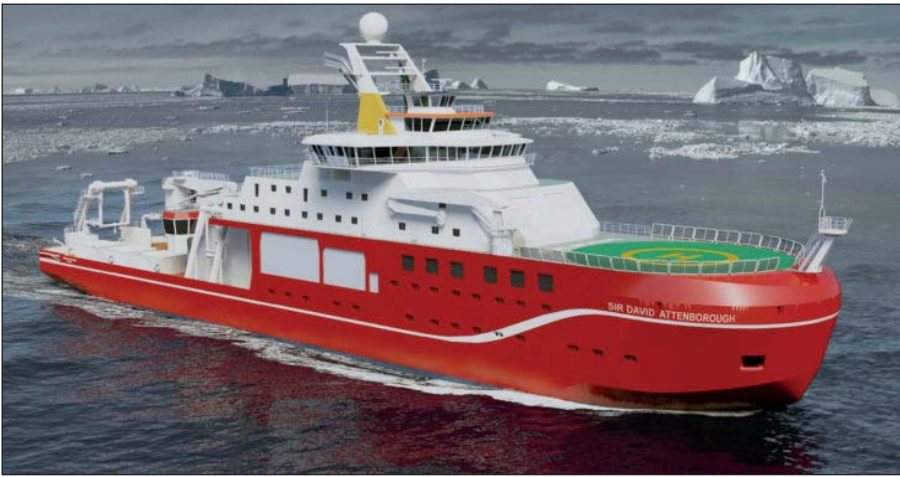
Ecospeed will now be applied to Sir David Attenborough (artist impression courtesy of BAS/Cammell Laird).

BAS/NERC selected Ecospeed for the newbuild RRS *Sir David Attenborough*. The 15,000gt polar research ship is under construction at the Cammell Laird shipyard in Birkenhead, Liverpool, UK.

The shipyard initially wanted to apply its preferred supplier's coating system, but based on their experience with the *Ernest Shackleton* and the *James Clark Ross*, BAS chose Ecospeed instead. The coating does not need to be applied under strict environmental conditions or require any sophisticated application equipment.

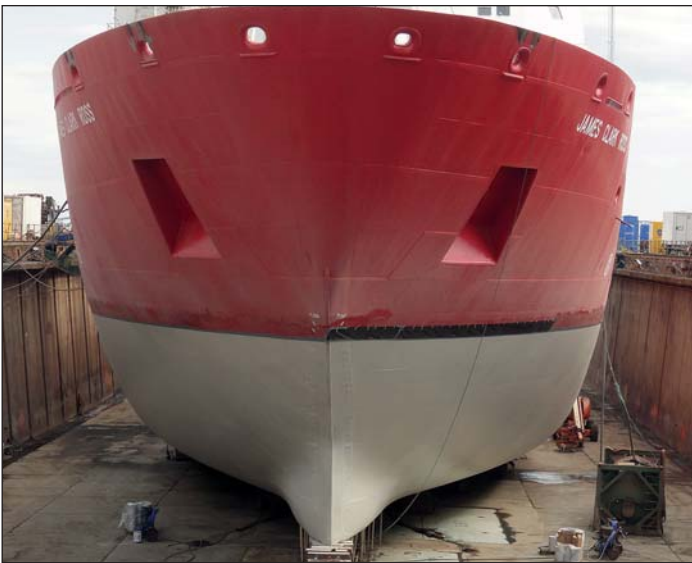
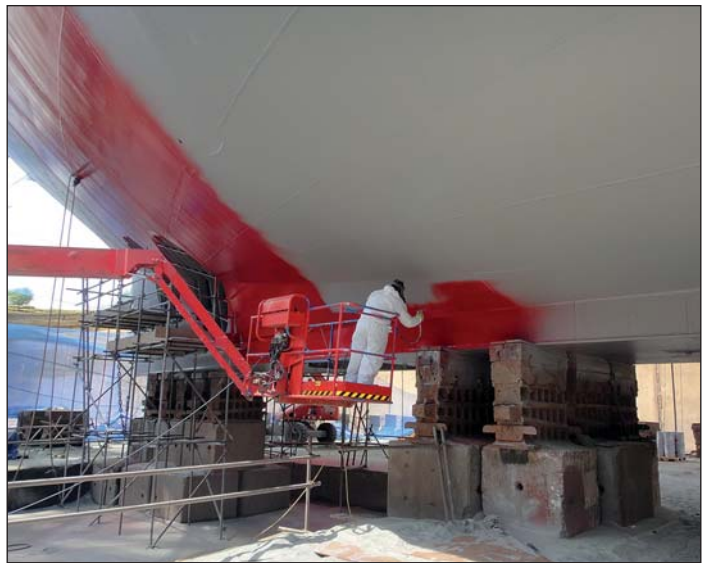
In 2015 the RRS James Clark Ross was coated with Ecospeed to protect the hull against impact with ice.

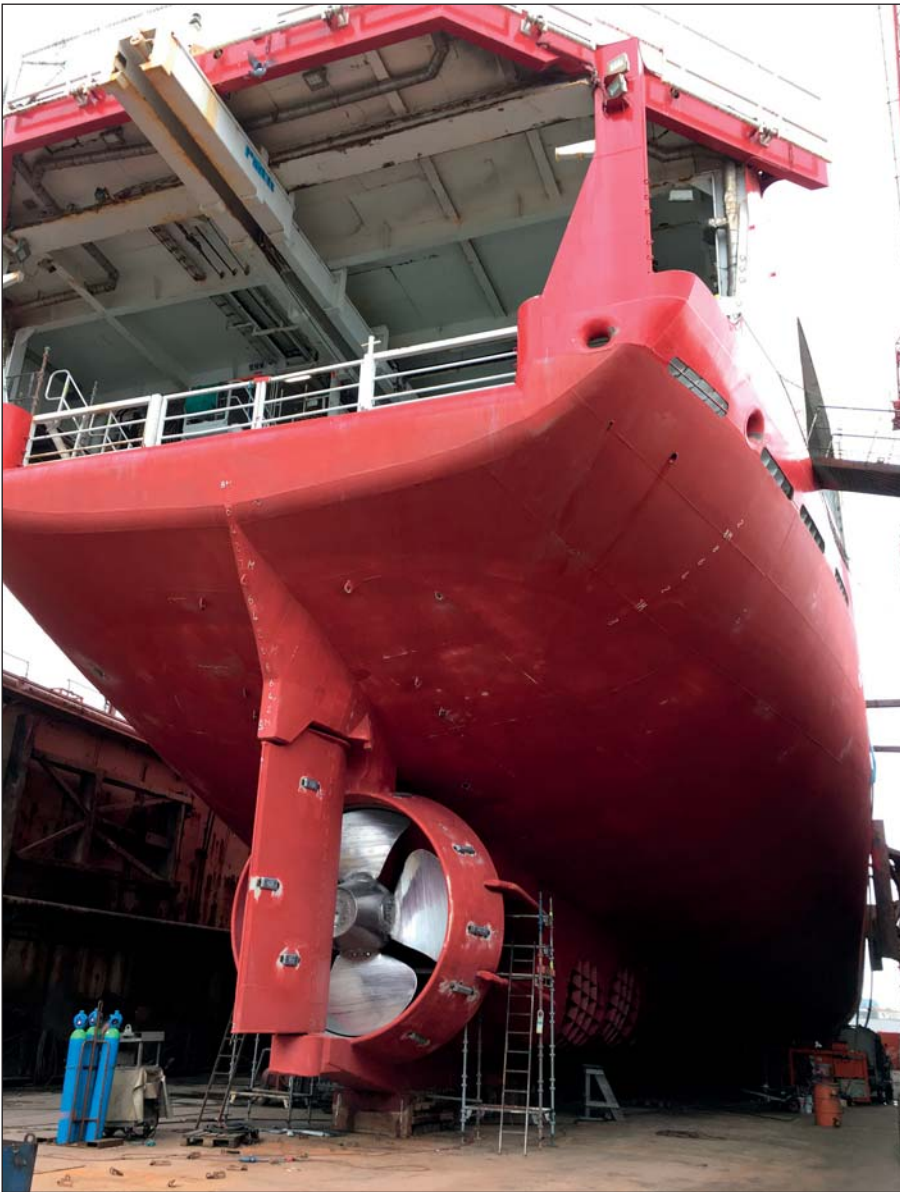
In eight seasons operating RRS Ernest Shackleton with Ecospeed coating, only those areas most susceptible to ice impact needed touch-ups.

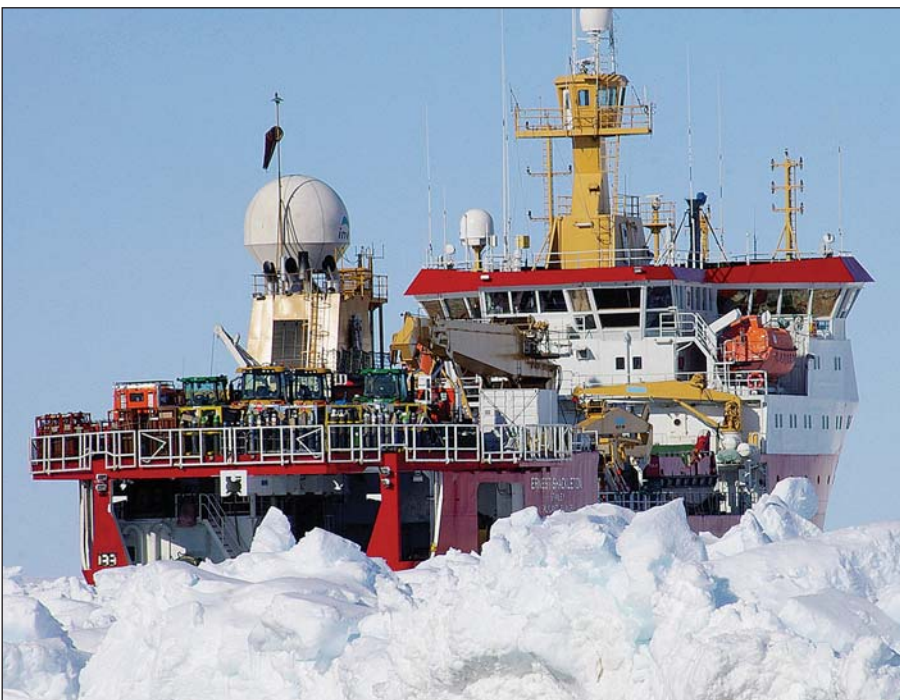
RRS Ernest Shackleton in Antarctic ice up to 2.5 m thick.

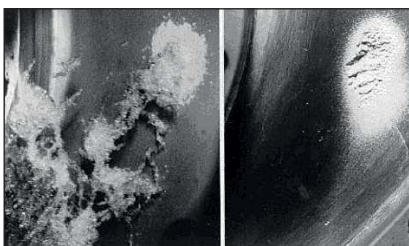
Cavitation bubbles and resulting damage.

Hydrodynamic cavitation is a phenomenon that accompanies turbulent fluids. The turbulence in the fluid, caused by the ship's motion through the water and particularly by the action of the ship's propeller, results in areas of greatly reduced fluid pressure. Due to the low pressure, the water vapourises. This creates small, vapour-filled cavities or bubbles in the fluid up to about 3mm in diameter. The cavities travel through the water and the pressure around them increases, causing them to suddenly collapse. The implosion of the cavities is accompanied by a complex set of physical processes. It is the collapse of the cavities and the

attendant high pressure pulses, speeds and temperatures in the water that cause the damage.

The forces involved are very large. It is as if the surface affected has been subjected to repeated, heavy blows from a hammer accompanied by high temperatures. This causes what is known as cavitation erosion as the surface material, first paint and then steel, begins to flake away. The process can be greatly magnified by the presence of gravel or other hard particles in the water.

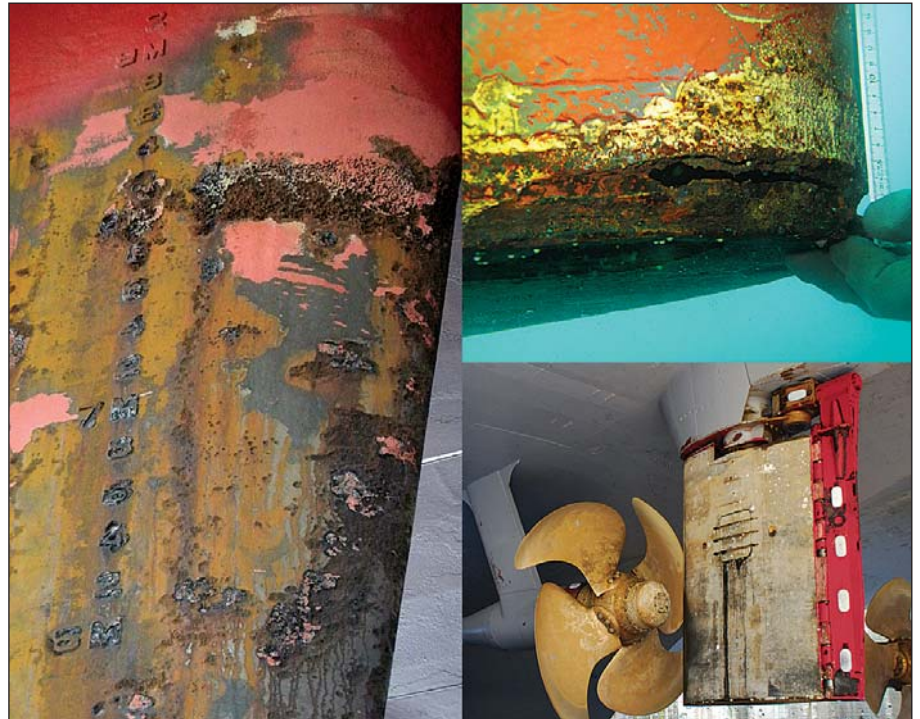
Rudders with cavitation erosion damage.

One need only examine a ship's rudder that has been subjected to cavitation damage to see that very real damage is caused by this phenomenon. Rudders become deeply pitted, paint coatings and hard steel simply disappear, whole plates can fall off and the rudder practically

disintegrates altogether – all as a result of this cavitation damage.

The process can take place in a remarkably short period of time. Sometimes six months is all it takes for serious rudder damage to occur. The first step is that the cavitation causes the paint coating on the steel to erode, eventually exposing bare steel. The erosion of the steel is then accompanied by the electrochemical process of corrosion because the steel is no longer protected. The effect is multiplied as the cavitation continues, and the erosion it causes is augmented by the natural corrosion of bare steel exposed to water – the electrochemical process and the oxidation that this brings about.

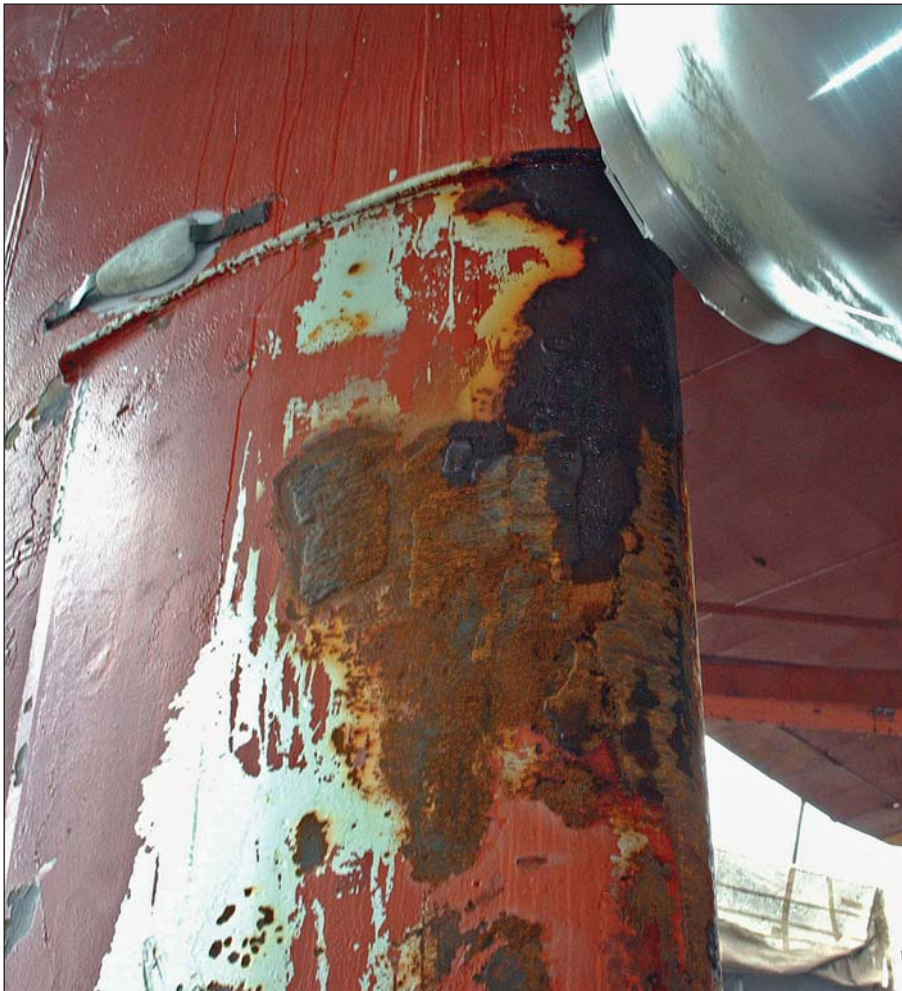
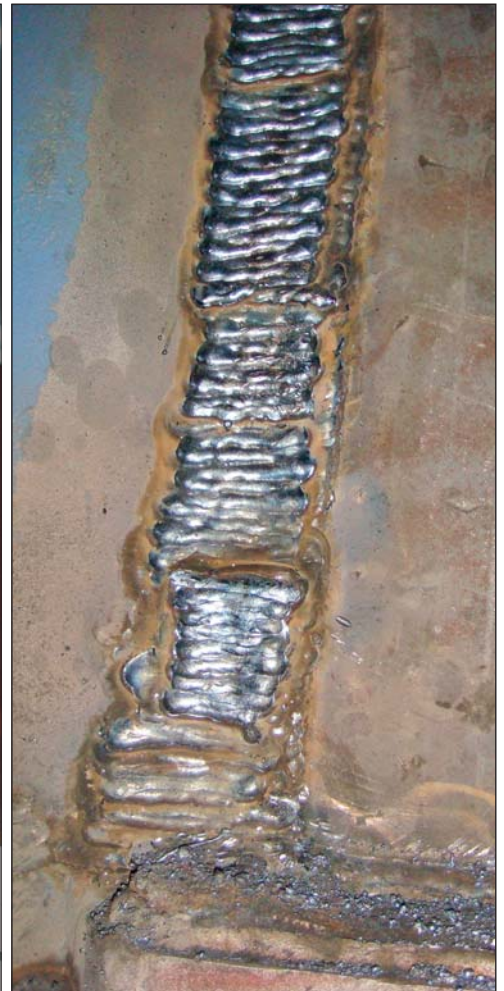
The damage caused by cavitation (left) and a typical welding repair (right).

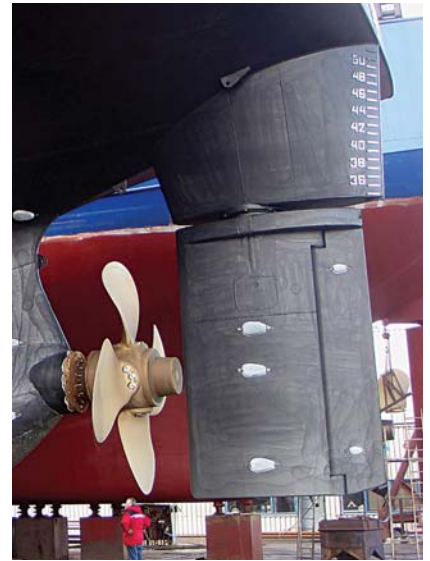
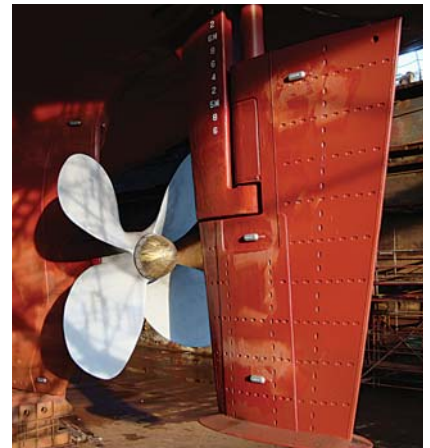
The rudder of the Maersk Deva after five years in service with conventional rudder coating (left), and five years after Ecoshield glassflake rudder coating was applied.
