# Ecospeed pays dividends for Interscan

Interscan's Michael Tensing explains why ice-traders need a hard coating. Mike Garside<sup>1</sup> reports.

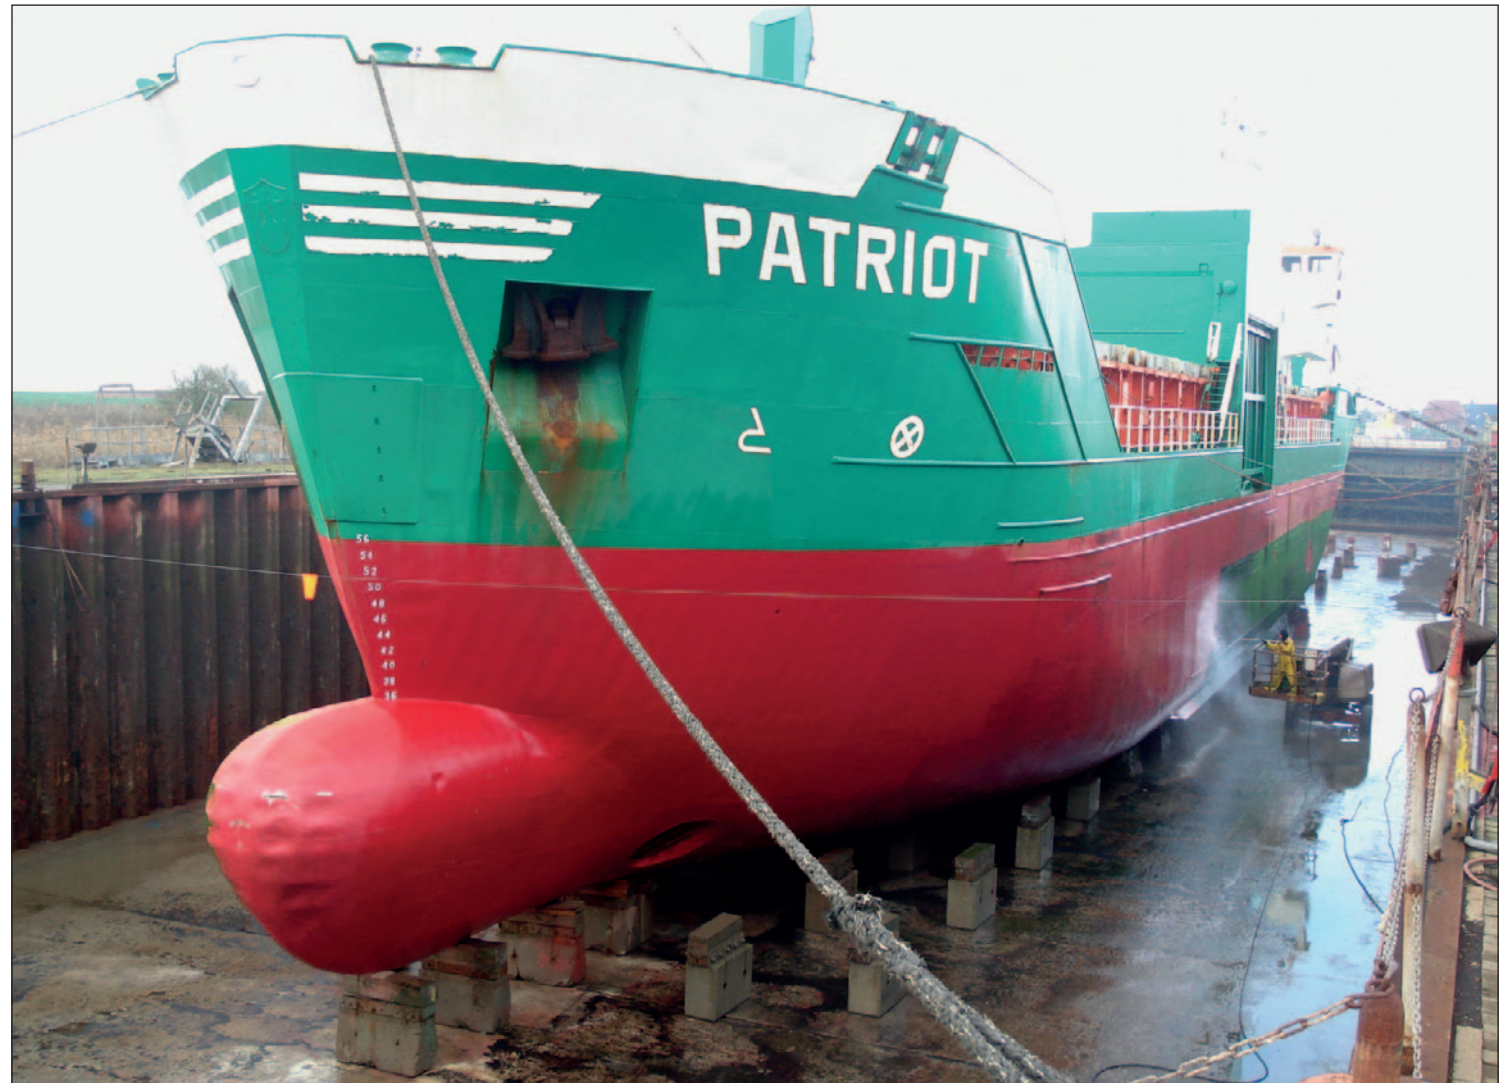
*Ecospeed can be easily cleaned in drydock or underwater without damaging the coating.*

He explained that during an Ecospeed vessel's scheduled drydocking the hull is simply pressure washed. Where there is mechanical damage, the coating is easily repaired by just painting over the damage with a brush – a major advantage over other types of coatings.

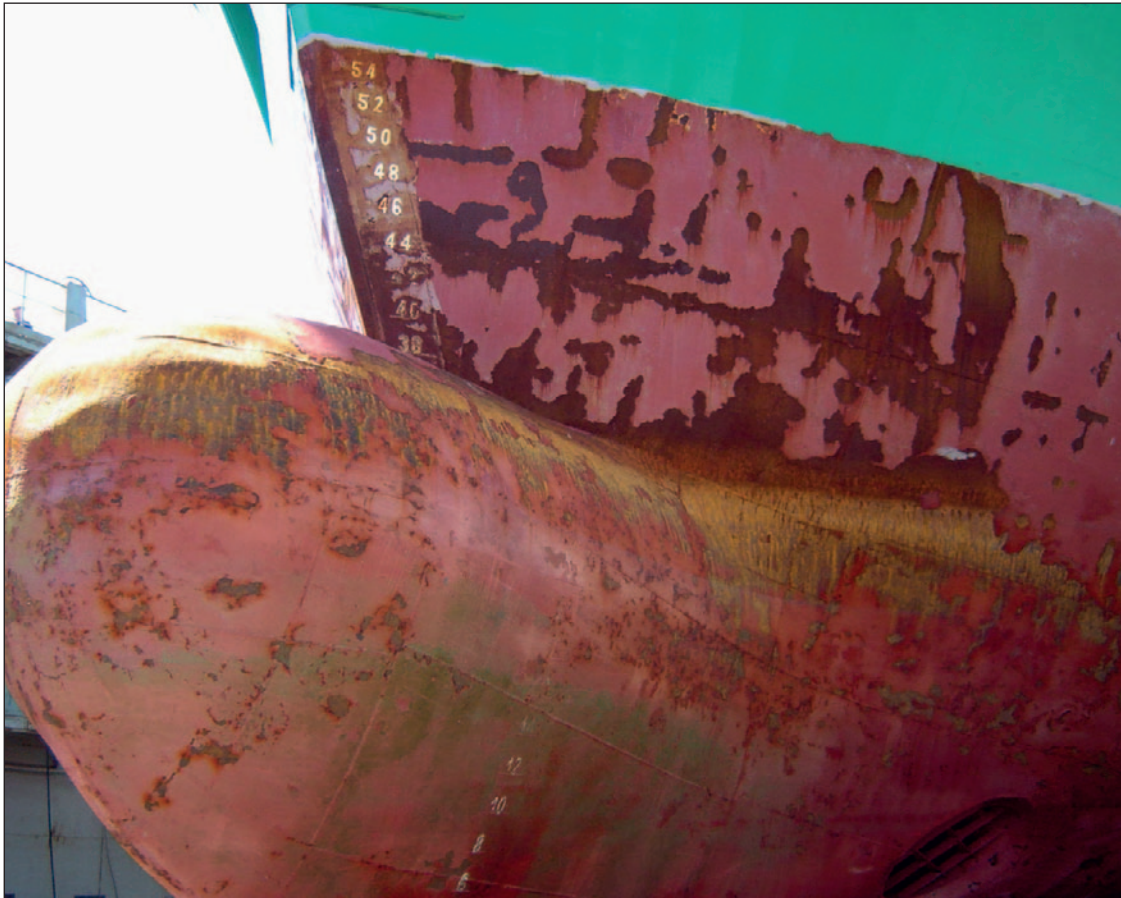
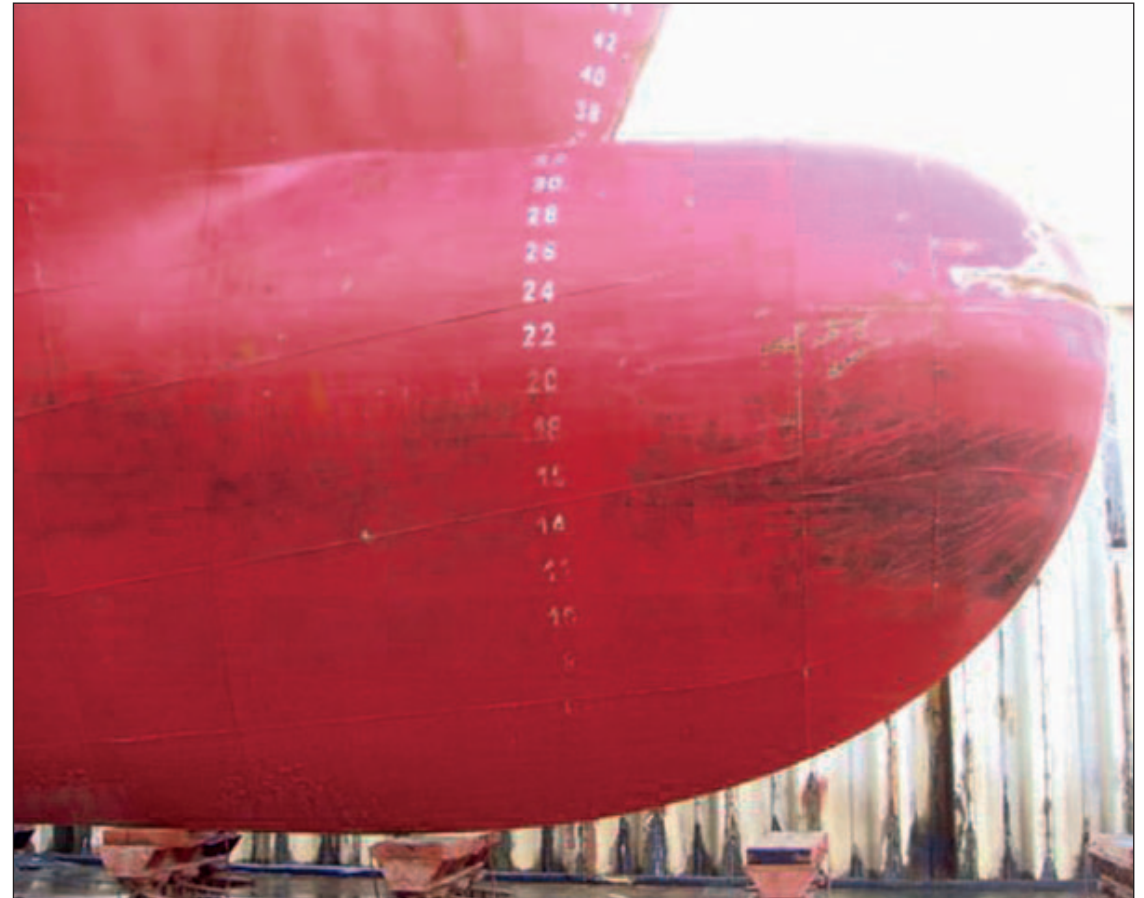
*The hull of the ice-going MV Patriot: left – usual condition at drydock before Ecospeed application, and right – on return to drydock after 5 years trading in the ice with its Ecospeed coating.*

"*Patriot* was coated ten years ago and has traded in

ice every year since then; but the coating has lasted perfectly well. Before Ecospeed we used normal epoxy coatings which would last for, perhaps, one to two winters. Now we need to pay no attention to

He added: “In 2015, after 10 years of trading on the same routes, the *Patriot's* Ecospeed coating is still going strong. We are very impressed with it and now have the coating on seven vessels; six coasters and one MPP. It's performed very well for us.”

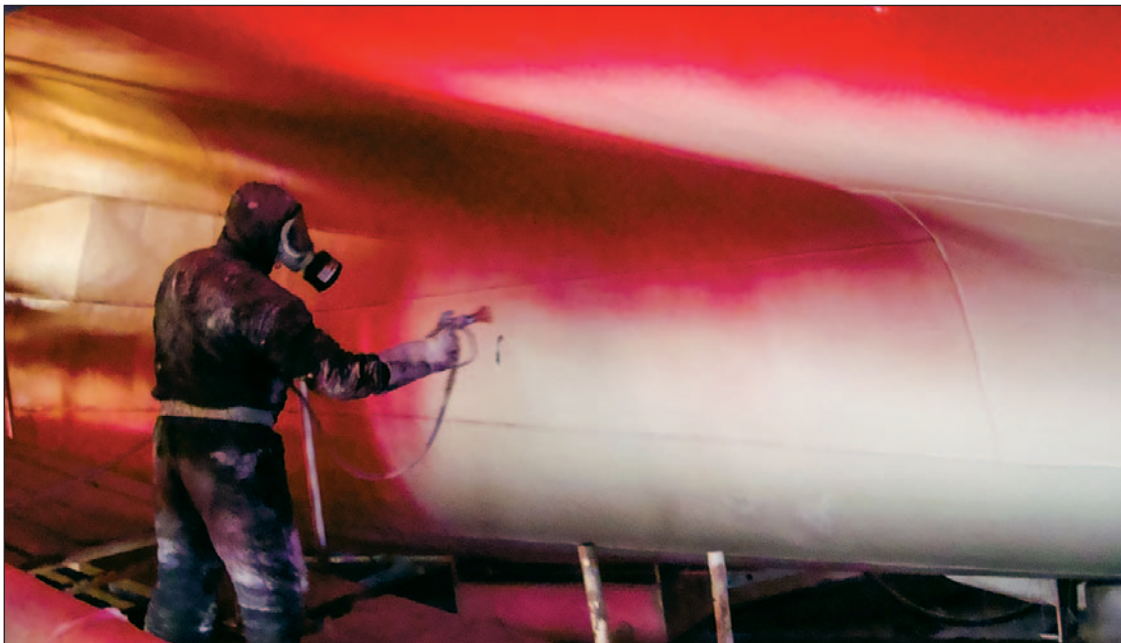
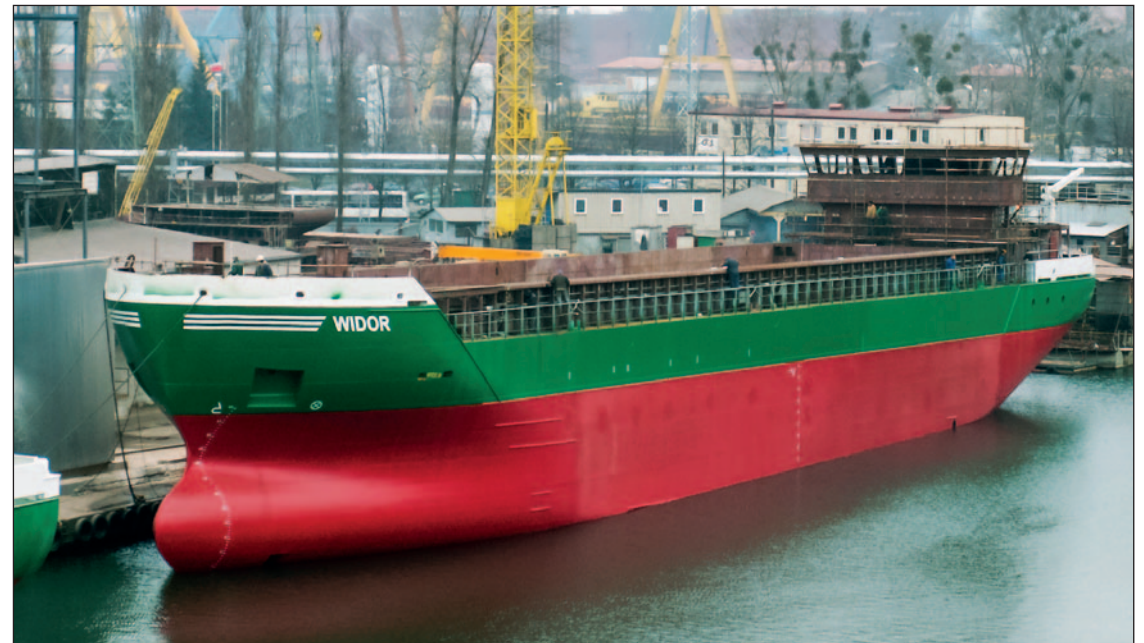
*MV Widor being painted and after launch.*

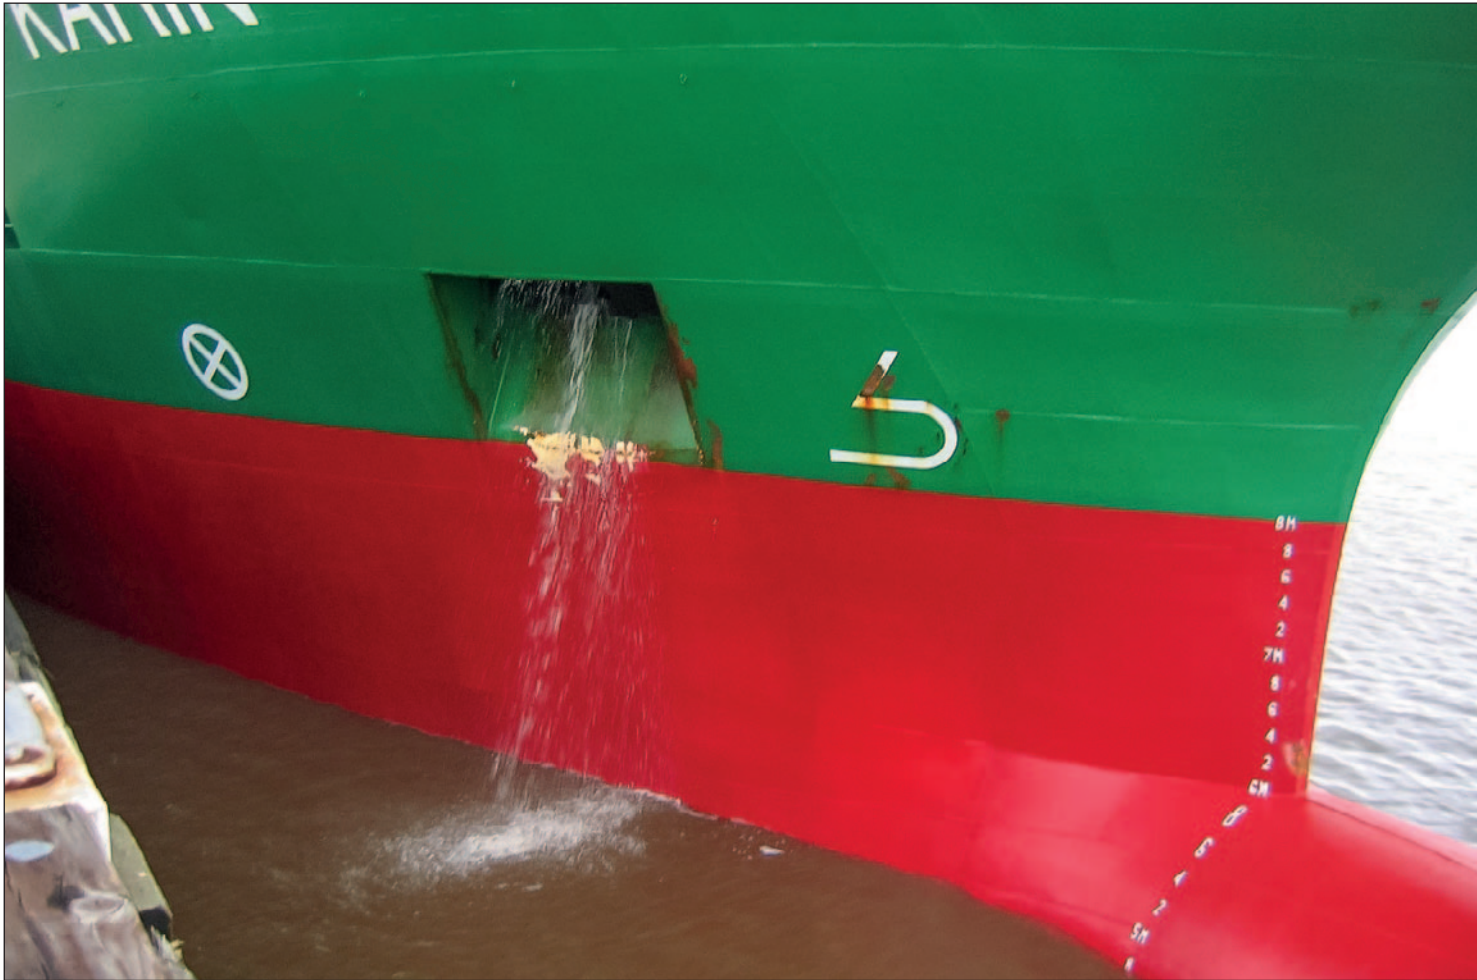
*MV Karin several years after initial application.*

Referring to Interscan's 6288dwt general cargo ship *Karin*, which had Ecospeed applied following the success of the *Patriot* coating, Tensing said: “*Karin* sails in warm waters and in those conditions it might need an underwater cleaning every six months but it is an easy procedure because the coating is very tough. Cleaning takes only 6 to 8 hours.”
